Review paper

ASSESSMENT OF PROTECTIVE STRUCTURES FOR ARCHITECTURAL HERITAGE: CASE STUDY OF POMPEII, LEPENSKI VIR AND GOBEKLI TEPE

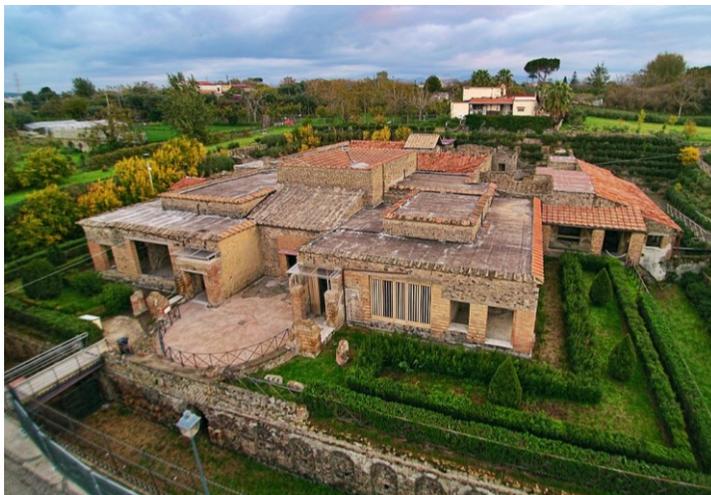
Villa dei Misteri, one of the most famous villas in Pompeii, stands out for its frescoes depicting mysterious rites. Its history dates back to the 2nd century BCE, with significant construction phases documented over different periods. Discovered in 1909, the villa now draws visitors eager to experience the unique atmosphere of ancient Roman times (Fig. 1) [13].

Figure 1. A suburban villa located next to the main archaeological area of Pompeii - Villa dei Misteri, source <https://www.nomenclatorbooks.com/villapage.html> (18.03.2024.)

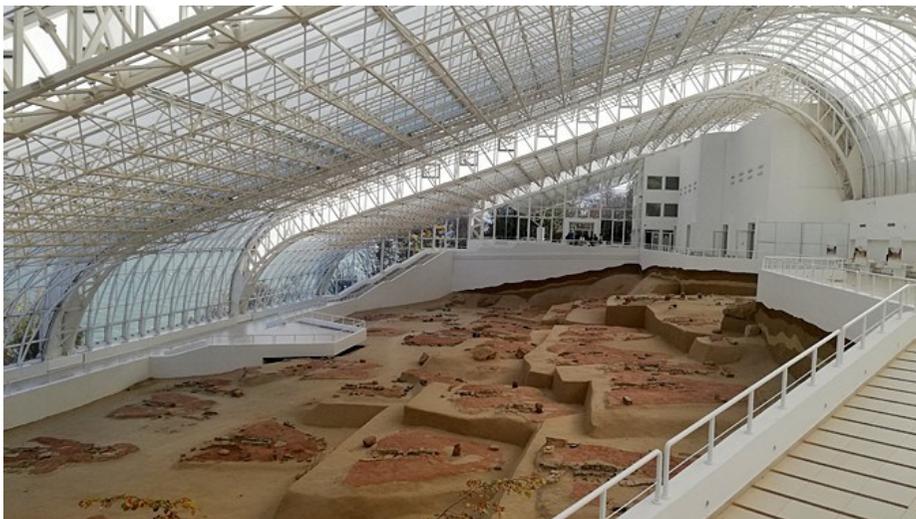
It also plays a significant role in its visual presentation. The installation of transparent glass panels to allow for increased insolation draws a parallel with the organization of houses in the fishing settlement, as the former housing units were oriented towards the south with their wider side (Fig. 4).

Figure 4. View from the inside of the building, source <https://www.politika.rs/sr/clanak/456203/Ugrozeno-arheolosko-nalaziste-Lepenski-vir> (26.02.2024.)

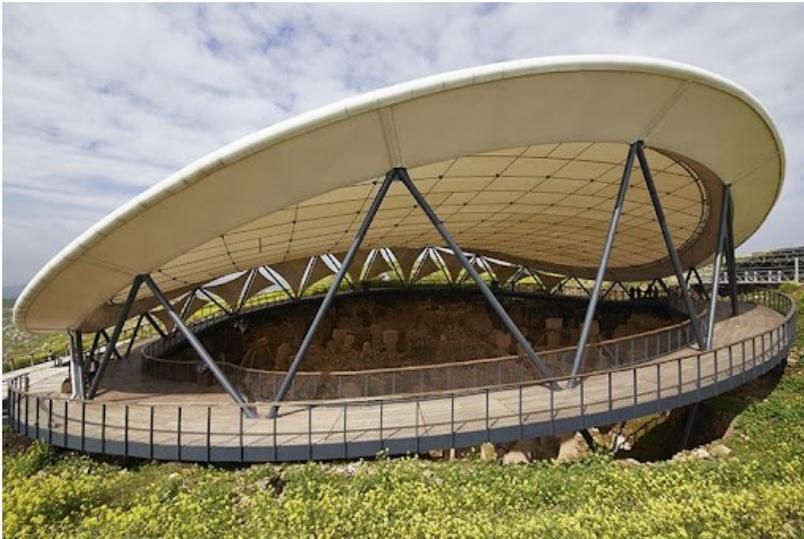
The steel skeleton of the roof structure forms the shape of a hyperbolic paraboloid, with all vertical structural elements located on the outside. The membrane is semi-transparent, allowing daylight to pass through, enhancing the visual comfort of visitors (Fig. 6) [16].

Figure 6. View of the protective structure from the east side, source <http://www.transtinsaat.com/proje-detay/29/sanliurfa-gobeklitepe.html> (27.02.2024.)
