original scientific paper

LANDSLIDE STABILISATION AND REHABILITATION MEASURES ON THE REGIONALEN ROAD R-1202 MAVROVO - DEBAR, NORTH MACEDONIA

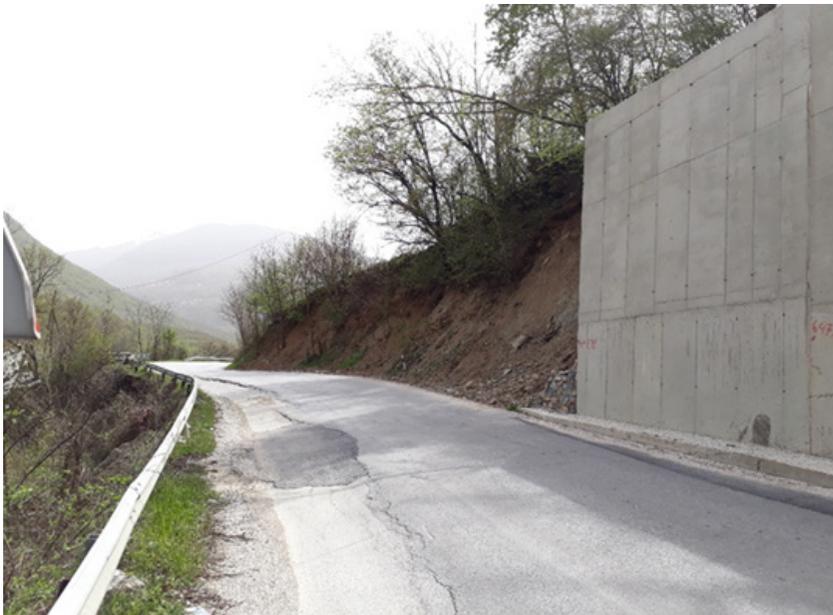
Figure 1 Landslide on the regional road Mavrovo-Debar

This paper develops solutions for landslide remediation located on the regional road R-1202 Mavrovo - Debar, chainage km 43 + 100 (Fig. 1). It is a route with lots of pronounced problems when it comes to slope stability. This can be a case due to a poorly built road, inadequate drainage of atmospheric waters, tectonic movements and similar.

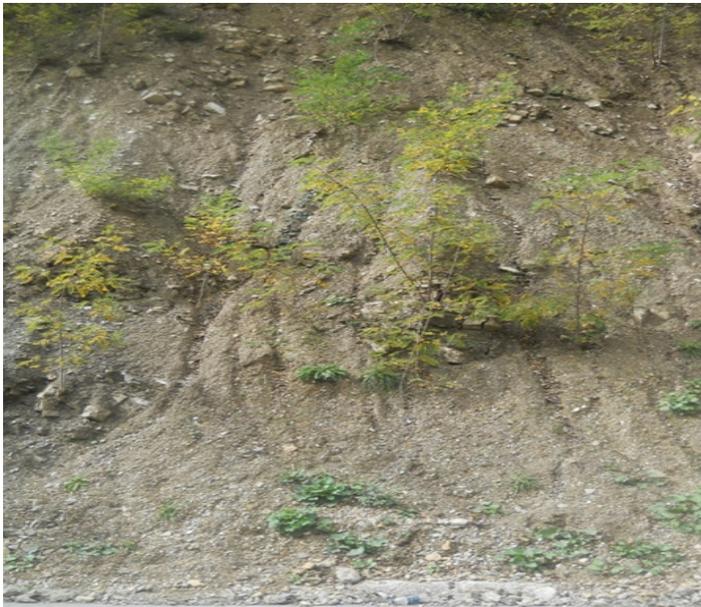
Figure 2 Geological structure of the terrain

The geological structure of the terrain (Fig. 2) is defined on the basis of previous research (according to the Elaborate for geotechnical field research and laboratory tests at the location of a potentially unstable zone on the regional road R1202 Mavrovo - Debar), engineering geological mapping and based on conducted exploratory drillings.

Based on that, it was concluded that in the geological construction of the exploration area there are: chinks, flysch sediments built of sandstones, clay shales and aleurolites, on which limestone lies. In the surface part there are deluvial creations that are a product of surface physical-mechanical decomposition of rock masses under the action of external (atmospheric) influences [3]. On one part of the slope, a crushing material was found, which was knocked down from the upper parts of the slope and settled on the slope itself. Also, on part of the terrain, presence of embankment material was ascertained, which probably originates from the excavation of the slope during the construction of the road, as well as from slope's landslide cleaning.
